# ETHIOPIA

## THE PROJECT

Project Location: Edo Community Center, Ethiopia

## CHARACTERISTICS OF THE WELL

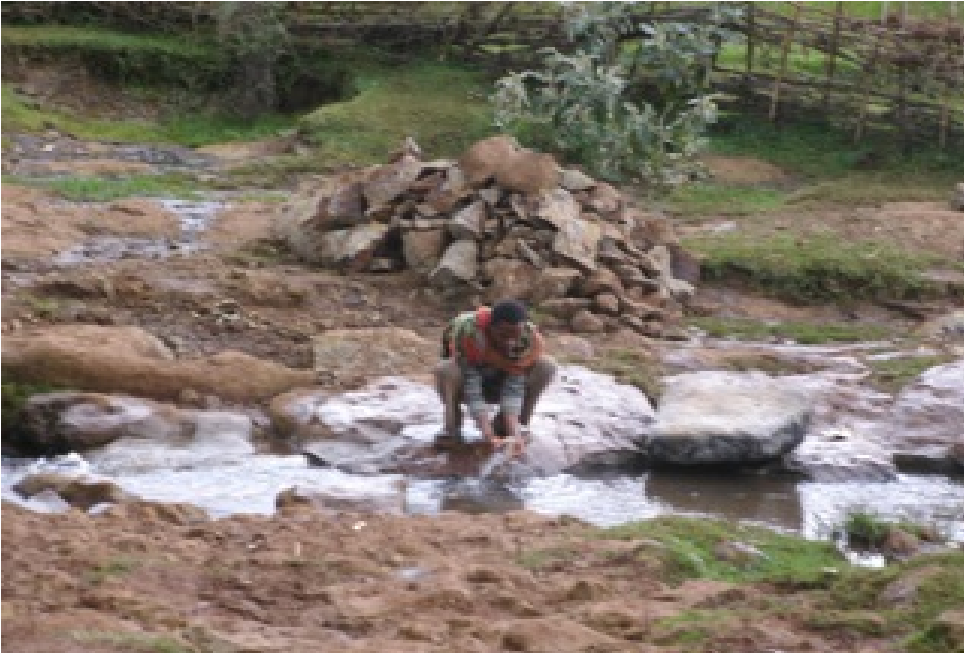
Previous Water Source

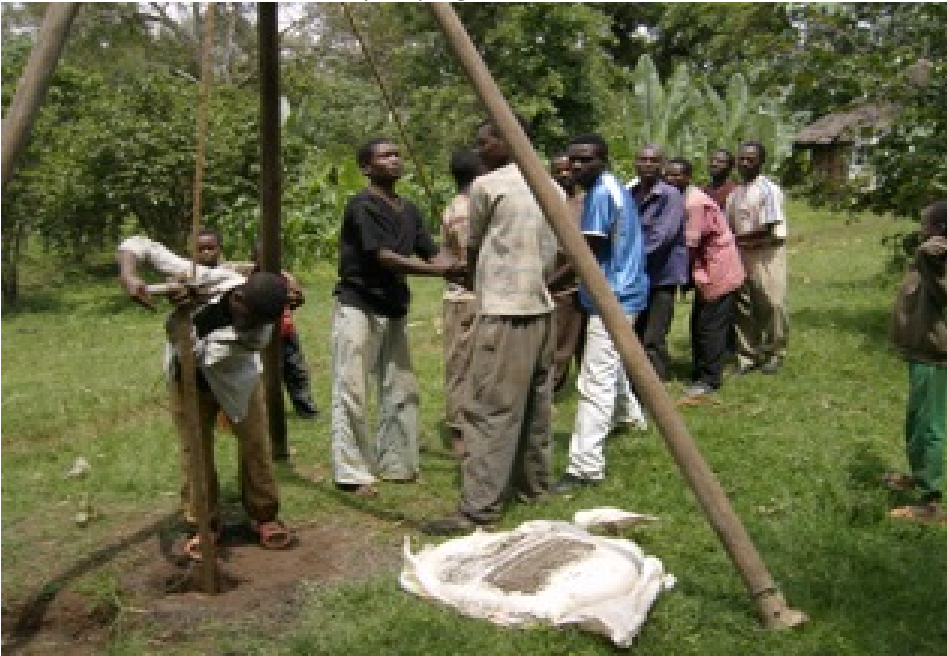
Project in Process
